**DEPARTMENT OF TRANSPORTATION**

Contract #: 04-0120F4Cty: SF/ALA Rte: 80 PM: 13.2/13.9File #: 1.28**WELDING INSPECTION REPORT****Resident Engineer:** Pursell, Gary**Address:** 333 Burma Road**City:** Oakland, CA 94607**Report No:** WIR-015495**Date Inspected:** 08-Jul-2010**Project Name:** SAS Superstructure**OSM Arrival Time:** 700**Prime Contractor:** American Bridge/Fluor Enterprises, a JV**OSM Departure Time:** 1530**Contractor:** American Bridge/Fluor Enterprises, a JV**Location:** Jobsite**CWI Name:** See below**CWI Present:** Yes No**Inspected CWI report:** Yes No N/A**Rod Oven in Use:** Yes No N/A**Electrode to specification:** Yes No N/A**Weld Procedures Followed:** Yes No N/A**Qualified Welders:** Yes No N/A**Verified Joint Fit-up:** Yes No N/A**Approved Drawings:** Yes No N/A**Approved WPS:** Yes No N/A**Delayed / Cancelled:** Yes No N/A**Bridge No:** 34-0006**Component:** SAS OBG**Summary of Items Observed:**

- 1). OBG Field Splice 1W/2W Weld ID: D1 & D2 Face B
- 2). OBG Field Splice 1W/2W Weld ID: F Face A
- 3). OBG Field Splice 2W/3W Weld ID: D1 & D2 Face B
- 4). OBG Field Splice 2W/3W Weld ID: B Face A
- 5). OBG Field Splice 3E/4E Weld ID: D1 & D2 Face B
- 6). OBG

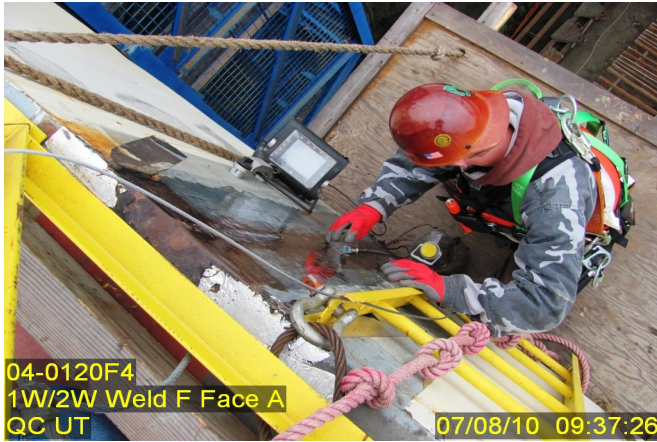
- 2). OBG Field Splice 1W/2W Weld ID: F Face A

A Face of OBG Field Splice 1W/2W Weld ID: F. See photo below. Mr. McConnel utilized the UT Procedure identified as SE-UT-D1.5-CT-100 Rev.4 during the examination of the CJP. The QC technician performed the shear wave testing utilizing a .63 x .75 rectangular transducer to test for weld soundness. The UT examination was completed during this shift. At the conclusion of the QC testing the QAI observed that the QC technician noted two (2) rejectable flaws which were marked on the A face of the groove weld. The QAI spoke with Mr. McConnel who stated that there are a total of four rejectable indications found from face A and face B.

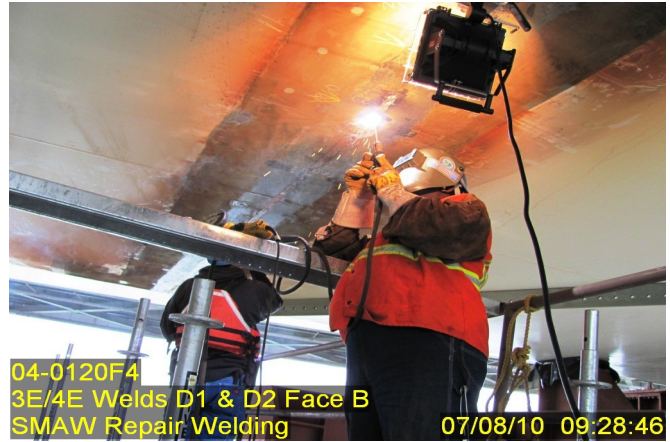
### 5). OBG Field Splice 3E/4E Weld ID: D1 & D2 Face B

The QAI periodically observed AB/F approved welder Fred Kaddu (2188) performing repair welding of multiple UT repairs on the B face of OBG Field Splice 3E/4E Weld ID: D1 & D2. The repair welding was per the Shielded Metal Arc Welding (SMAW) process in the 4G (overhead) position. See photo below. QC Inspector Tony Sherwood was present to monitor the progress and verify that the welding parameters were within the limits established by the approved welding Procedure Specification (WPS) identified as ABF-WPS-D1.5-1001-repair. Welding at this location was in process for the remainder of this shift and appeared to be in general compliance with contract documents.
